NASA/TP-97-206257

The Characteristics of Fatigue Damage in the Fuselage Riveted Lap Splice Joint

Robert S. Piascik
Langley Research Center, Hampton, Virginia

November 1997

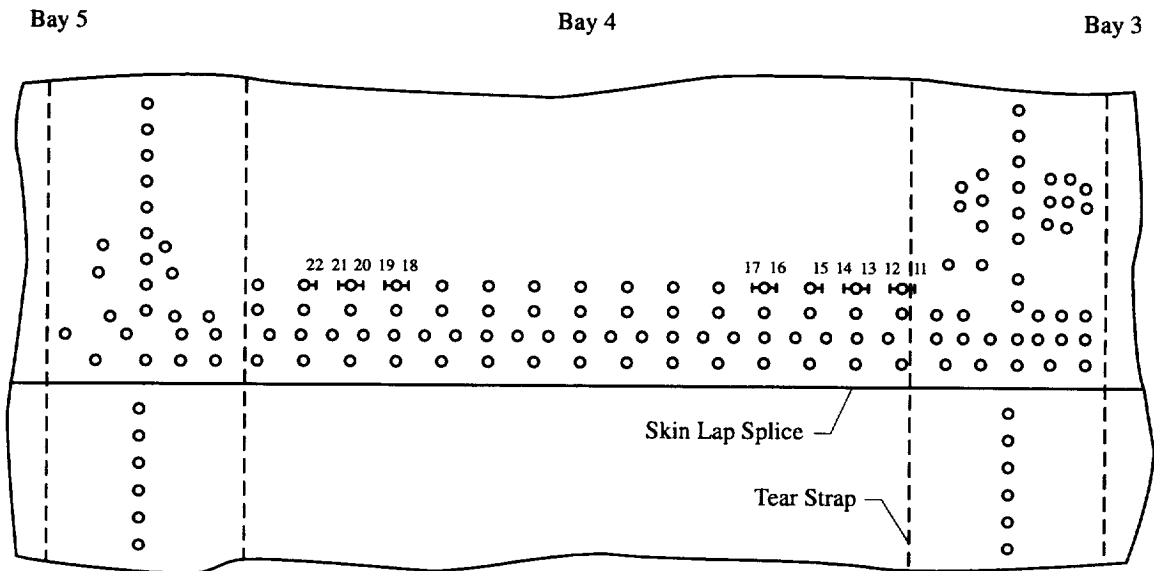
Figure 4.7 The schematic shows the location of possible cracks as detected by the X-ray inspection for the bay 4/5 T.S., bay 4 and the bay 3/4 T.S. regions. Crack indications #11-22 were found in the upper rivet row of bay 4. Dashed lines mark the tear strap regions.

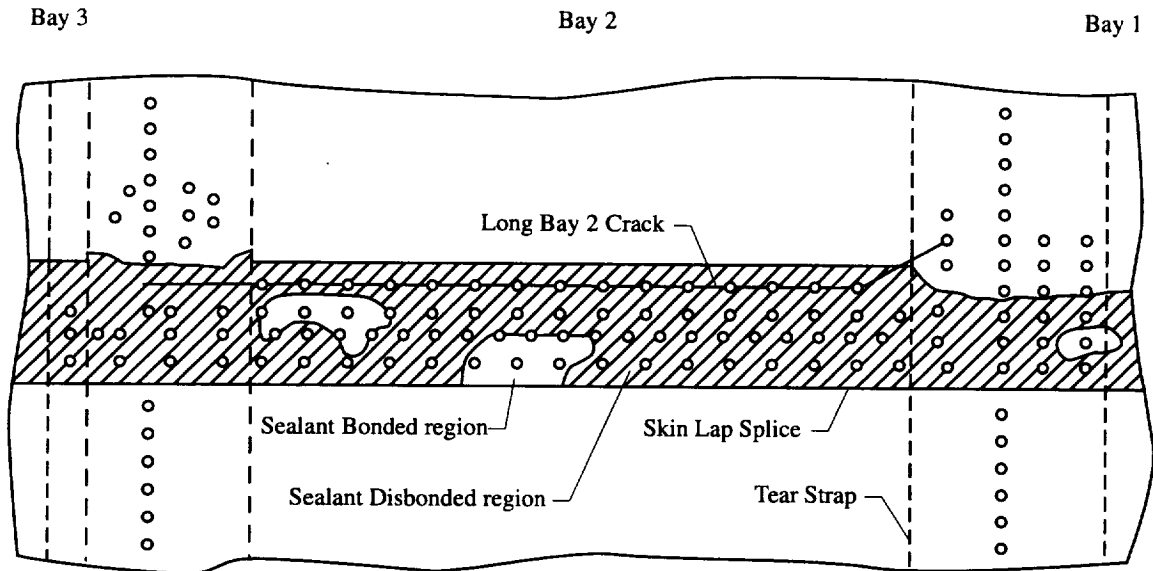
The sealant in the lap splice and the bond in the tear strap joints were inspected from the exterior surface using the ultrasonic inspection technique using a NDT Instruments Bondascope 2100, an L1 probe at 164.6 KHz transducer, and Sonotech Soundclear normal viscosity acoustic couplant under a specific acoustic impedance mode of operation. The UT technique was used to detect regions along the inner surface of the joints that were not completely sealed or bonded. A map of the UT inspection results summarized in Figures 4.8, 4.9, 4.10, and 4.11 reveal that extensive regions in the lap splice joint were not completely sealed (shaded regions) and only small islands were sealed. All tear strap regions were found to be well bonded with the exception of the lower ends of the upper straps, immediately adjacent to the lap. These ends were found to be partially unbonded.

Figure 4.8 The schematic shows the result of the ultrasonic disbond detection technique for bay 2/3 T.S., bay 2 and the bay 1 T.S. lap splice joint region. The shaded regions represent the area that is no longer sealed between the inner and outer skin. Dashed lines mark the tear strap regions. Some minor disbonding occurred in the tear strap region in the upper portion of the lap splice joints. A solid line along the upper rivet row depicts the long outer skin crack in bay 2.

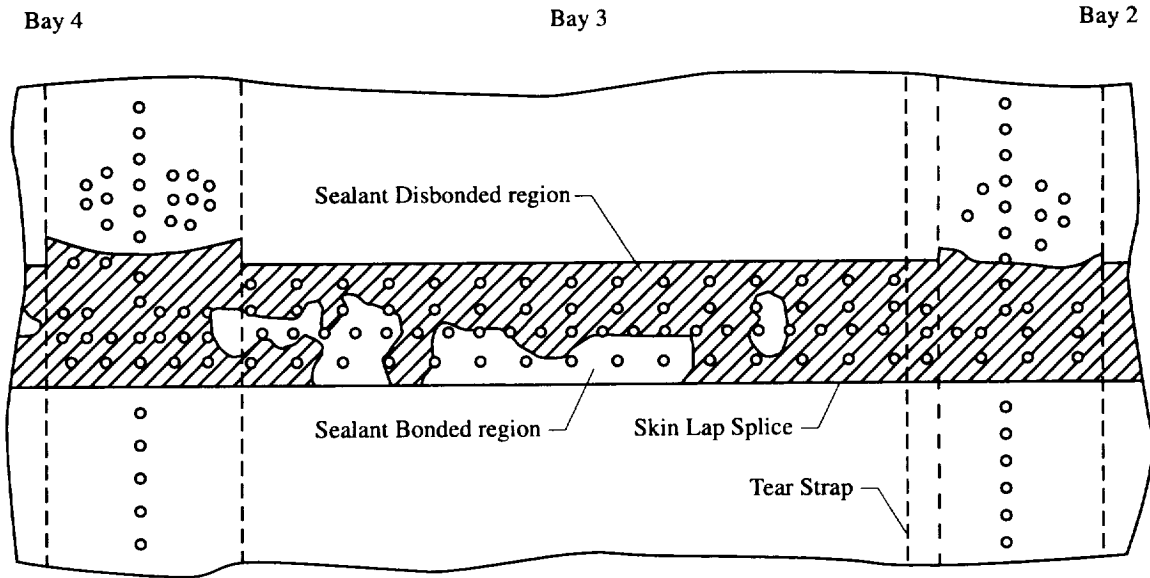
Figure 4.9 The schematic shows the results of the ultrasonic disbond detection technique for bay 3/4 T.S., bay 3 and the bay 2/3 T.S. lap splice joint region. The shaded regions represent the area that is no longer sealed between the inner and outer skin. Dashed lines mark the tear strap regions. Some minor disbonding occurred in the tear strap region in the upper portion of the lap splice joints.

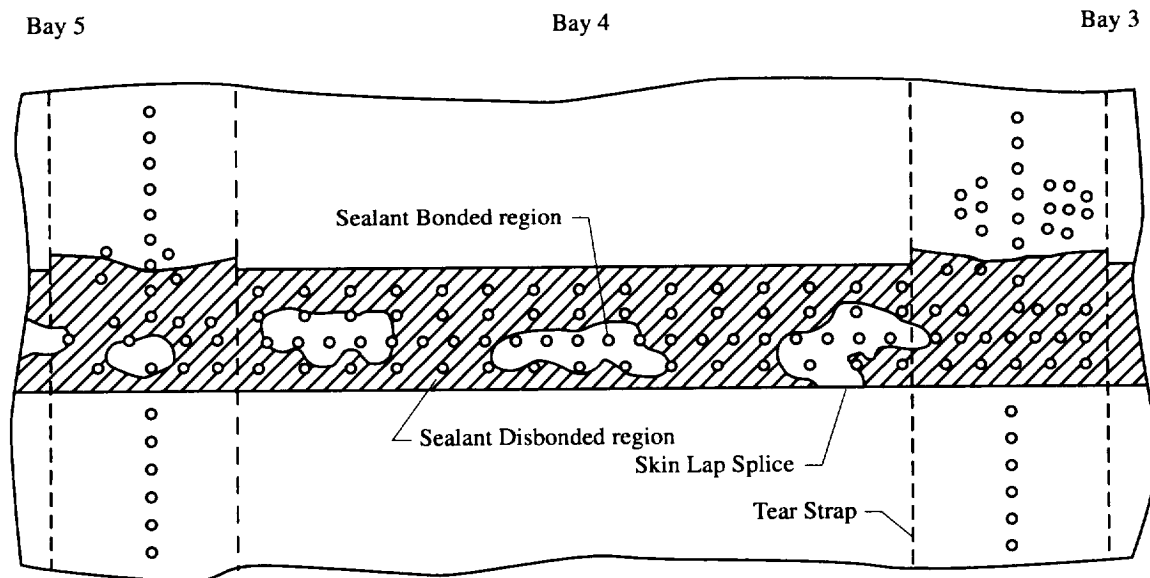
Figure 4.10 The schematic shows the results of the ultrasonic disbond detection technique for bay 4/5 T.S., bay 4 and the bay 3/4 T.S. lap splice joint region. The shaded regions represent the area that is no longer sealed between the inner and outer skin. Dashed lines mark the tear strap regions.

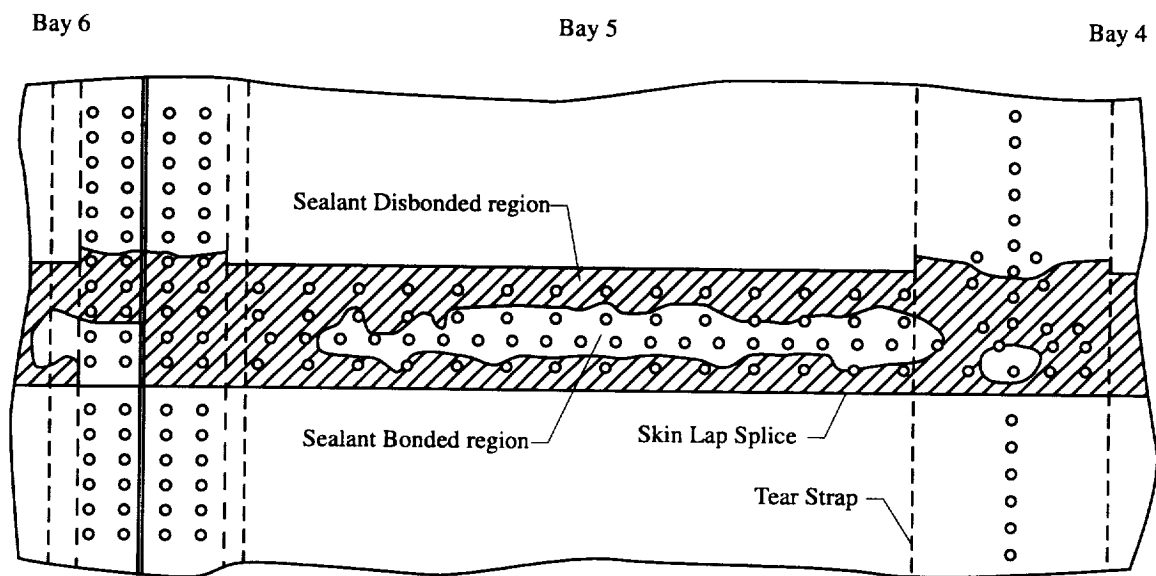
Figure 4.11 The schematic shows the results of the ultrasonic disbond detection technique for bay 5/6 T.S., bay 5 and the bay 4/5 T.S. lap splice joint region. The shaded regions represent the area that is no longer sealed between the inner and outer skin. Dashed lines mark the tear strap regions.

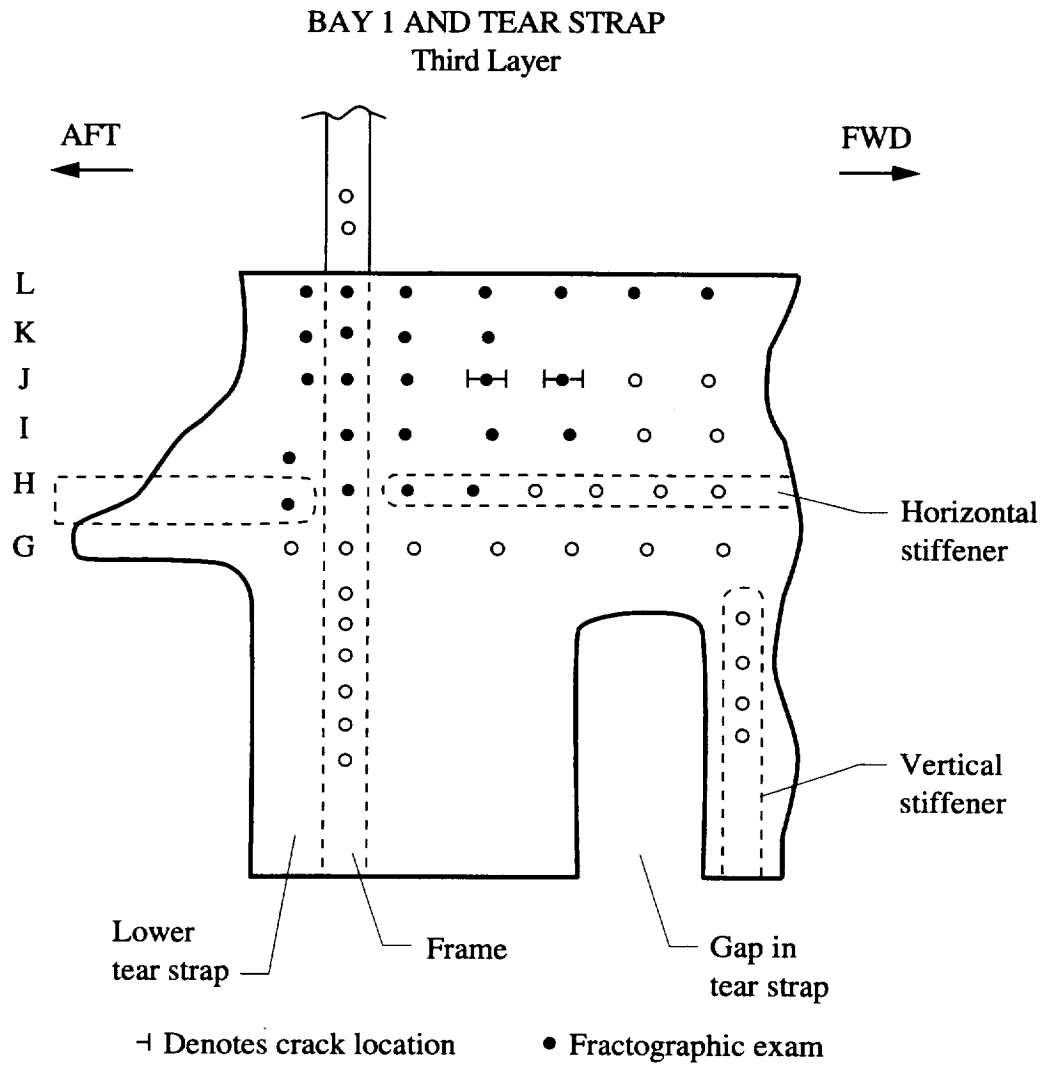
Figure 6.4 The schematic shows the location of fatigue cracks found in the third layer (lower tear strap) of the bay 1 tear strap and lap splice joint regions by destructive examination.

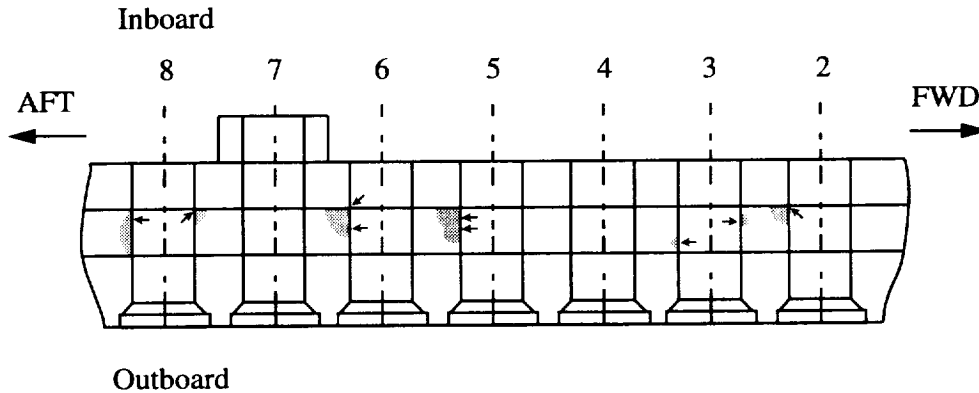
BAY 1 ROW L

6.4.1 Crack initiation site(s): Row L: Fatigue cracking was contained in the upper tear strap. Crack initiation occurred within the rivet hole surface or at a hole corner burr.

Hole #	Location	Length mm (in)	Type	Initiation site
2 (AFT)	U. tear strap	0.230 (0.009)	Corner	Inboard corner (I.C.)
3 (FWD)	U. tear strap	0.060 (0.002)	Multiple surface	Multiple center
3 (AFT)	U. tear strap	0.230 (0.009)	Multiple surface	Outboard side of center
5 (AFT)	U. tear strap	0.650 (0.026)	Multiple surface & corner	Surface and I.C.
6 (AFT)	U. tear strap	0.590 (0.023)	Multiple surface & corner	Multiple surface
8 (FWD)	U. tear strap	0.250 (0.010)	Corner	I.C.
8 (AFT)	U. tear strap	0.380 (0.015)	Corner	Inboard side of surface

Figure 6.5 The through thickness schematic shows the location and initiation site (small arrows) of fatigue cracks found in rivet row L from the bay 1 tear strap/lap splice joint region. The table summarizes crack location, crack length, crack type, and initiation site for each fatigue crack shown.

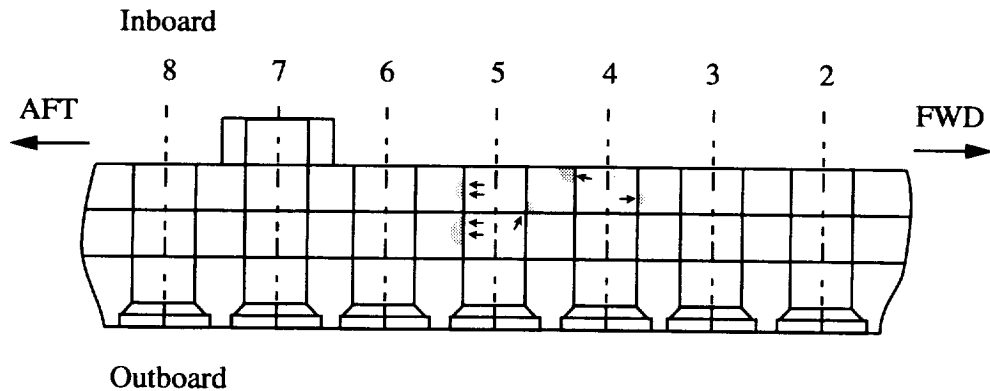
BAY 1 ROW J

Row J: Fatigue cracking was contained to the upper and lower tear strap. Crack initiation occurred within the rivet hole surface or at the hole corner.

Hole #	Location	Length mm (in)	Type	Initiation site
4 (AFT)	L.tear strap	0.425 (0.017)	Corner	Inboard corner
4 (FWD)	L.tear strap	0.220 (0.009)	Multiple surface	Outboard side of center
5 (1AFT)	U.tear strap	0.210 (0.008)	Multiple surface	Multiple sites in center
5 (2AFT)	L.tear strap	0.100 (0.004)	Multiple surface	Multiple sites in center
5 (FWD)	L.tear strap	0.260 (0.010)	Multiple corner	Outboard corner

Figure 6.6 The through thickness schematic shows the location and initiation site (small arrows) of fatigue cracks found in rivet row J from the bay 1 tear strap/lap splice joint region. The table summarizes crack location, crack length, crack type, and initiation site for each fatigue crack shown.

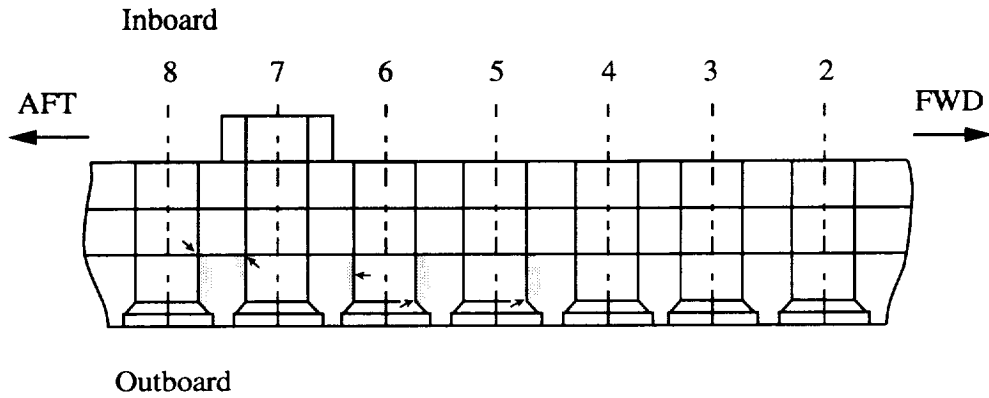
BAY 1 ROW I

Row I: Fatigue cracking was limited to the outer skin. Crack initiation occurred at the rivet hole shank region.

Hole #	Location	Length mm (in)	Type	Initiation site
5 (FWD)	Outer skin	0.420 (0.017)	Countersink	Outboard side of shank
6 (FWD)	Outer skin	1.160 (0.046)	Countersink	Outboard side of shank
6 (AFT)	Outer skin	0.200 (0.008)	Countersink	Center of shank
7 (AFT)	Outer skin	0.150 (0.006)	Countersink	Inboard side of shank
8 (FWD)	Outer skin	1.030 (0.041)	Countersink	Inboard side of shank

Figure 6.7 The through thickness row schematic shows the location and initiation site (small arrows) of fatigue cracks found in rivet row I from the bay 1 tear strap lap/splice joint region. The table summarizes crack location, crack length, crack type, and initiation site for each fatigue crack shown.

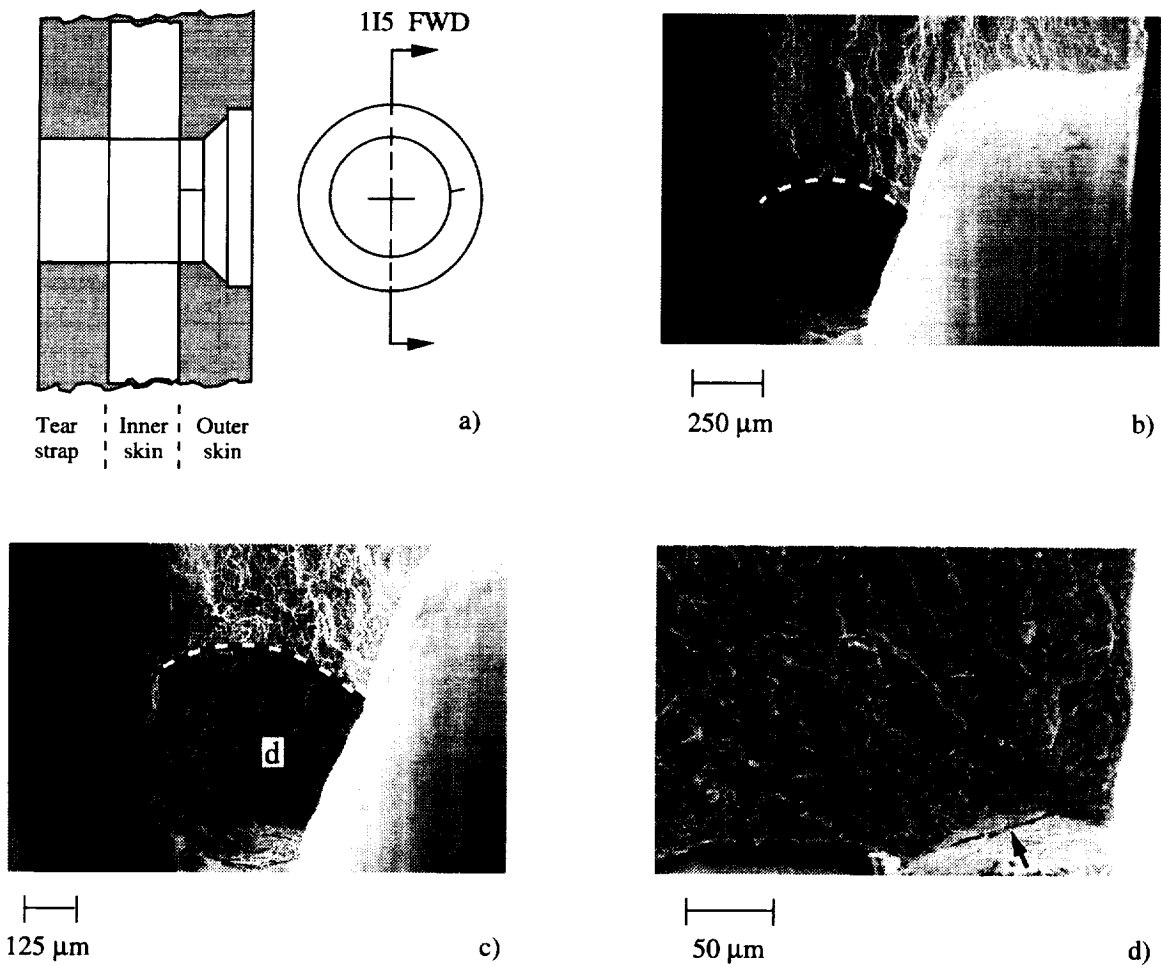
Figure 6.8 a) The schematic shows the rivet hole 115 configuration and the location of the outer skin fatigue crack oriented in the forward direction slightly above the 3 o'clock position. b) The SEM micrograph shows the fatigue crack location within the rivet hole. The dashed line marks the fatigue crack front. c) The SEM micrograph shows the fatigue crack region at higher magnification. d) The SEM micrograph shows region "d" in Figure 6.8.c at higher magnification. The likely crack initiation region is marked by an arrow. The mud cracking feature (upper right of arrow) is evidence of corrosion. The rivet was removed after pressure testing and the open rivet hole was exposed to the environment. It is likely corrosion occurred at that time.

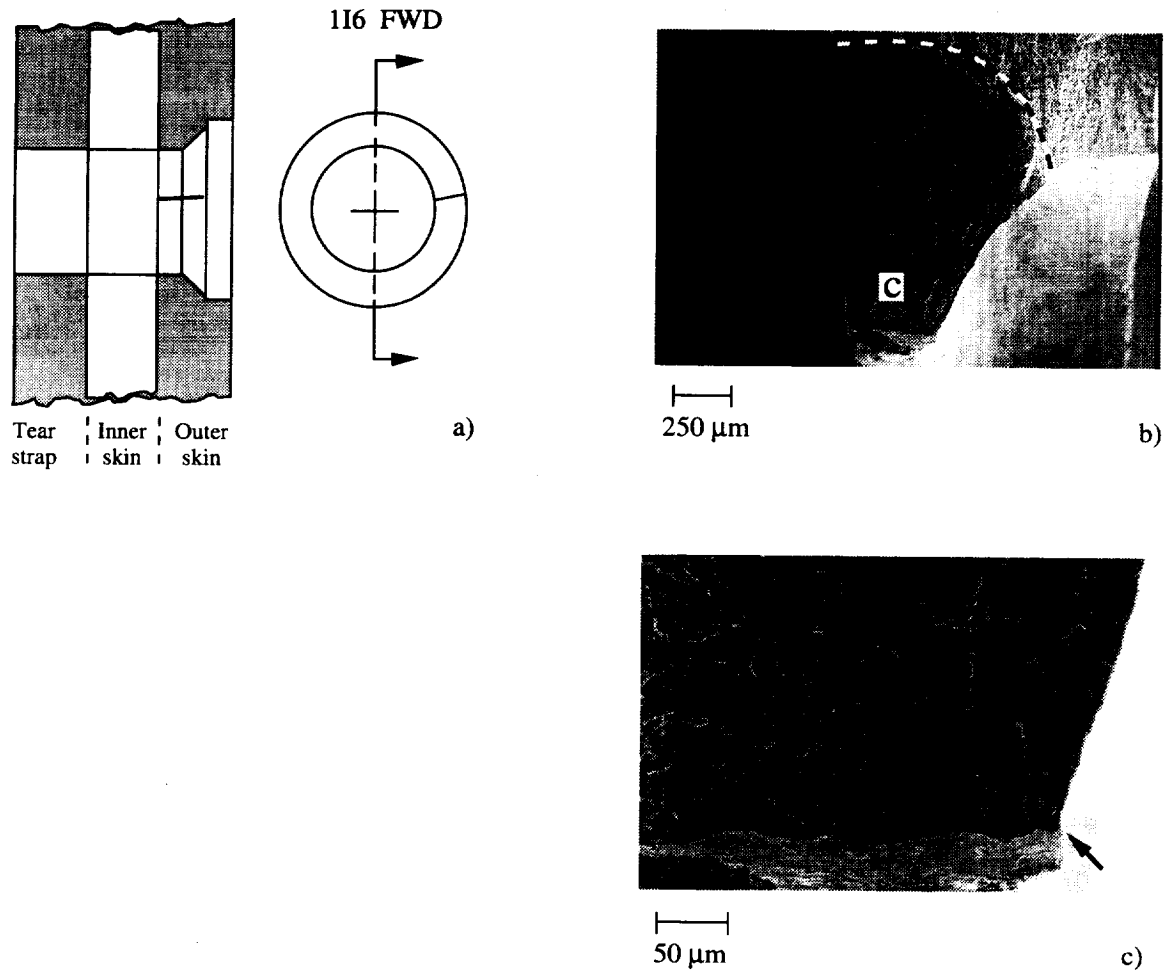
Figure 6.10 a) The schematic shows the rivet hole 116 configuration and the location of the outer skin fatigue crack oriented in the forward direction slightly above the 3 o'clock position. b) The SEM micrograph shows the fatigue crack location within the rivet hole. The dashed line marks the fatigue crack front. c) The SEM micrograph shows region "c" in Figure 6.10.b at higher magnification. The arrow marks the likely site of crack initiation.

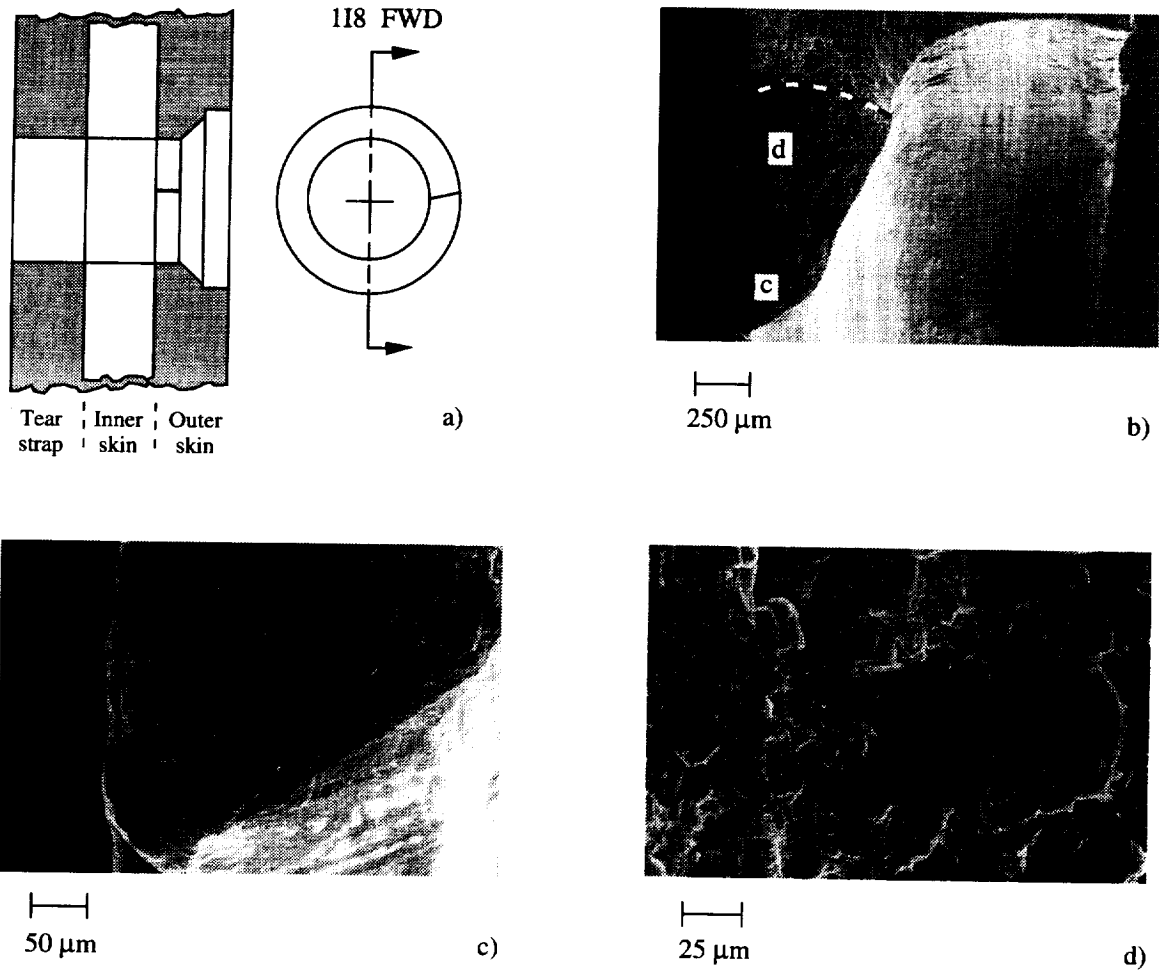
Figure 6.12 a) The schematic shows the rivet hole 118 configuration and the location of the outer skin fatigue crack oriented in the forward direction slightly above the 3 o'clock position. b) The SEM micrograph shows the fatigue crack location within the rivet hole. The dashed line marks the fatigue crack front. c) The SEM micrograph shows the crack initiation region "c" in Figure 6.12.b. Oxides covering the fracture surface mask the crack morphology around the site of crack initiation. d) The SEM micrograph shows the transgranular fatigue crack morphology in region "d" in Figure 6.12.b.

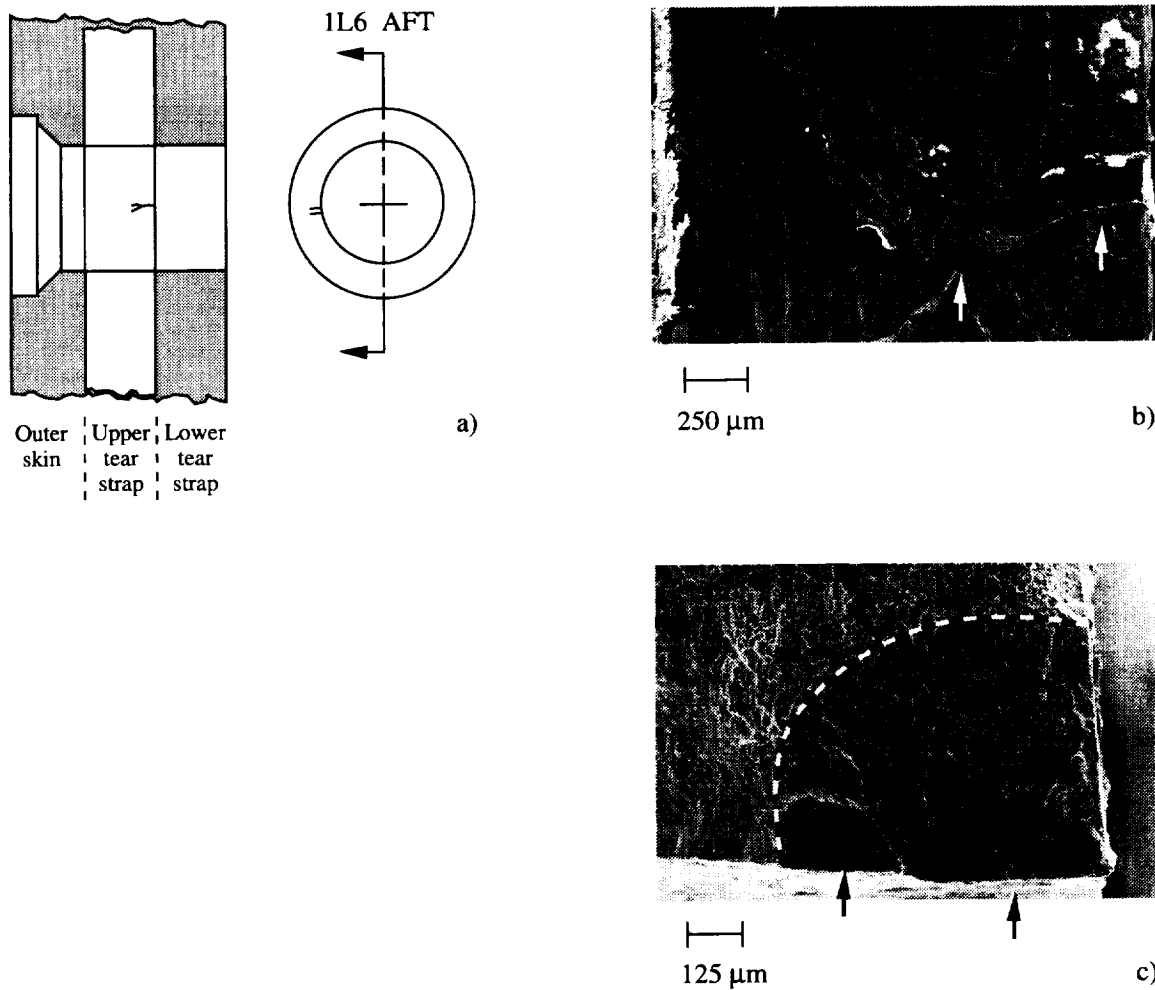
Figure 6.17 a) The schematic shows the rivet hole 1L6 configuration and the location of the upper tear strap fatigue crack oriented in the aft direction and about the 9 o'clock position. b) The SEM micrograph shows the surface and corner fatigue cracks that have been partially opened during the destructive examination. Arrows mark approximate location of crack initiation. c) The SEM micrograph shows the fatigue fracture surface of the corner and surface crack. The dashed line marks the fatigue crack front. Arrows mark the approximate location of crack initiation.

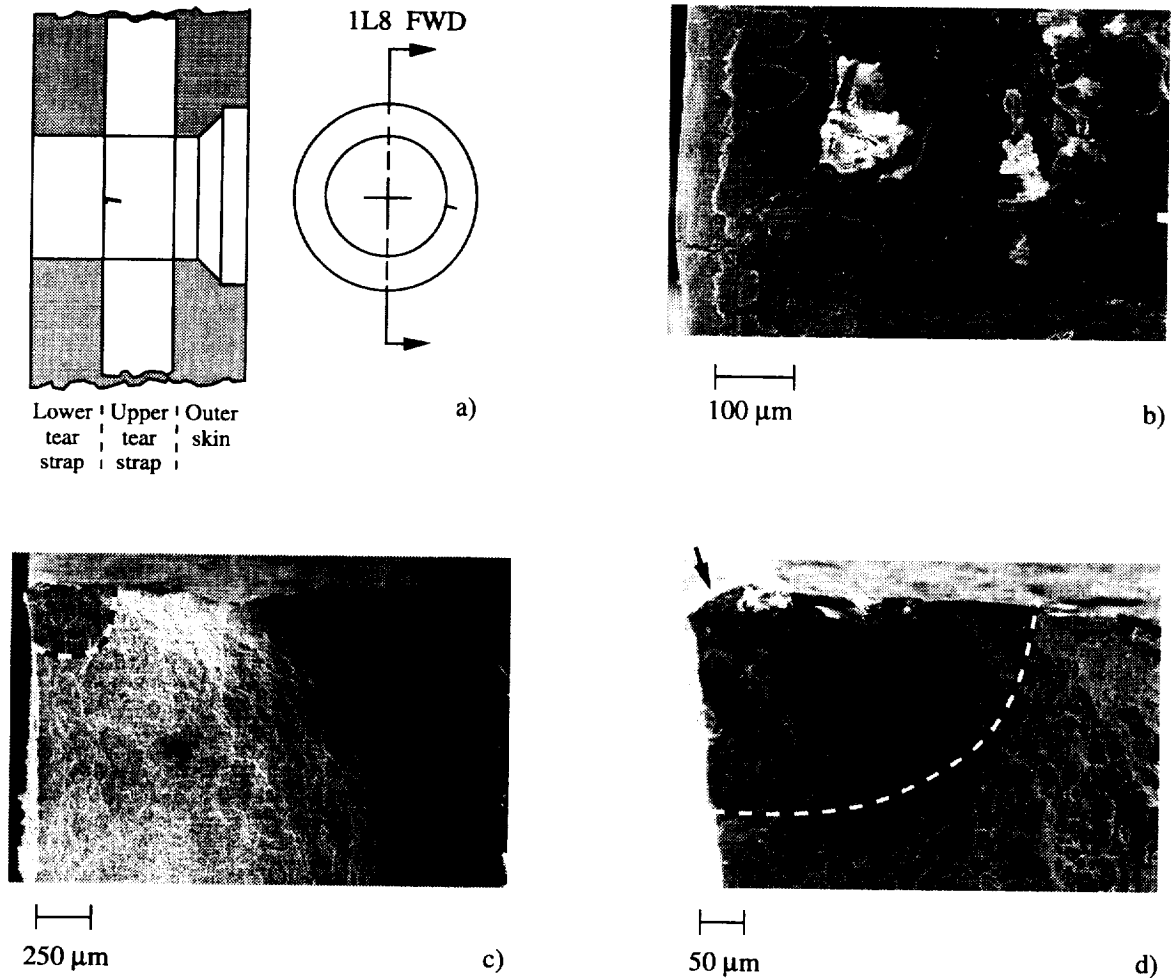
Figure 6.18 a) The schematic shows the rivet hole 1L8 configuration and the location of the upper tear strap fatigue crack oriented in the forward direction and about the 3 o'clock position. b) The SEM micrograph shows the tight corner fatigue crack prior to the destructive examination straining operation. c) The SEM micrograph shows the fatigue fracture surface of the corner crack. The dashed line marks the fatigue crack front. d) The SEM micrograph shows the fatigue fracture surface of the corner crack at higher magnification. White oxide debris near the corner marks the likely region of crack initiation (arrow).

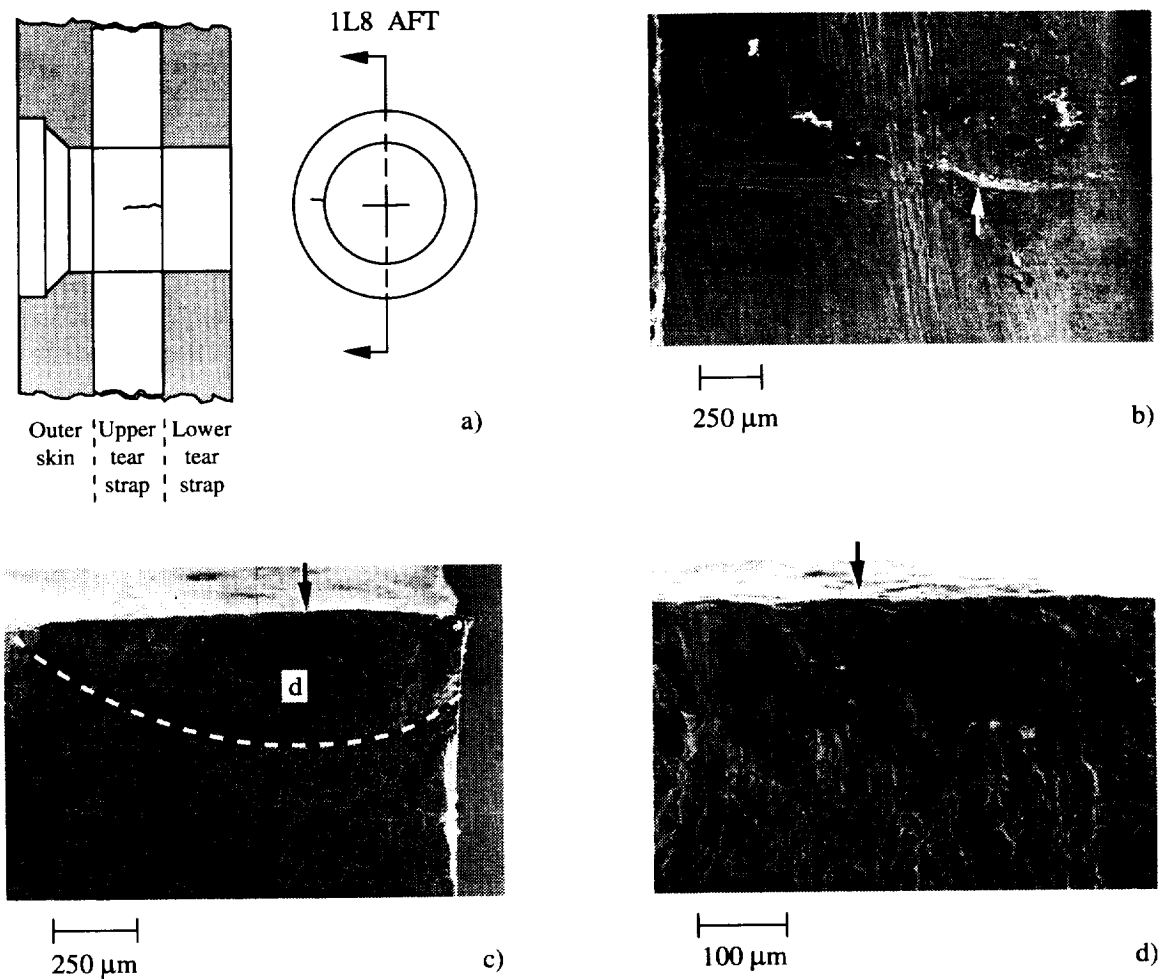
Figure 6.19 a) The schematic shows the rivet hole 1L8 configuration and the location of the upper tear strap fatigue crack oriented in the aft direction and about the 9 o'clock position. b) The SEM micrograph shows the tight corner fatigue crack (barely visible) prior to the destructive examination straining operation. The arrow marks the approximate crack initiation region. Note that a horizontal mark (disturbed metal) is located at the region of crack initiation. Other vertical markings are also visible. c) The SEM micrograph shows the fatigue fracture surface of the surface crack that has intersected the corner of the rivet hole. The arrow marks the approximate crack initiation region. The dashed line marks the fatigue crack front. d) The SEM micrograph shows the fatigue fracture surface of the crack initiation area, region "d" in Figure 6.19.c. Oxide debris is noted at the site of crack initiation.

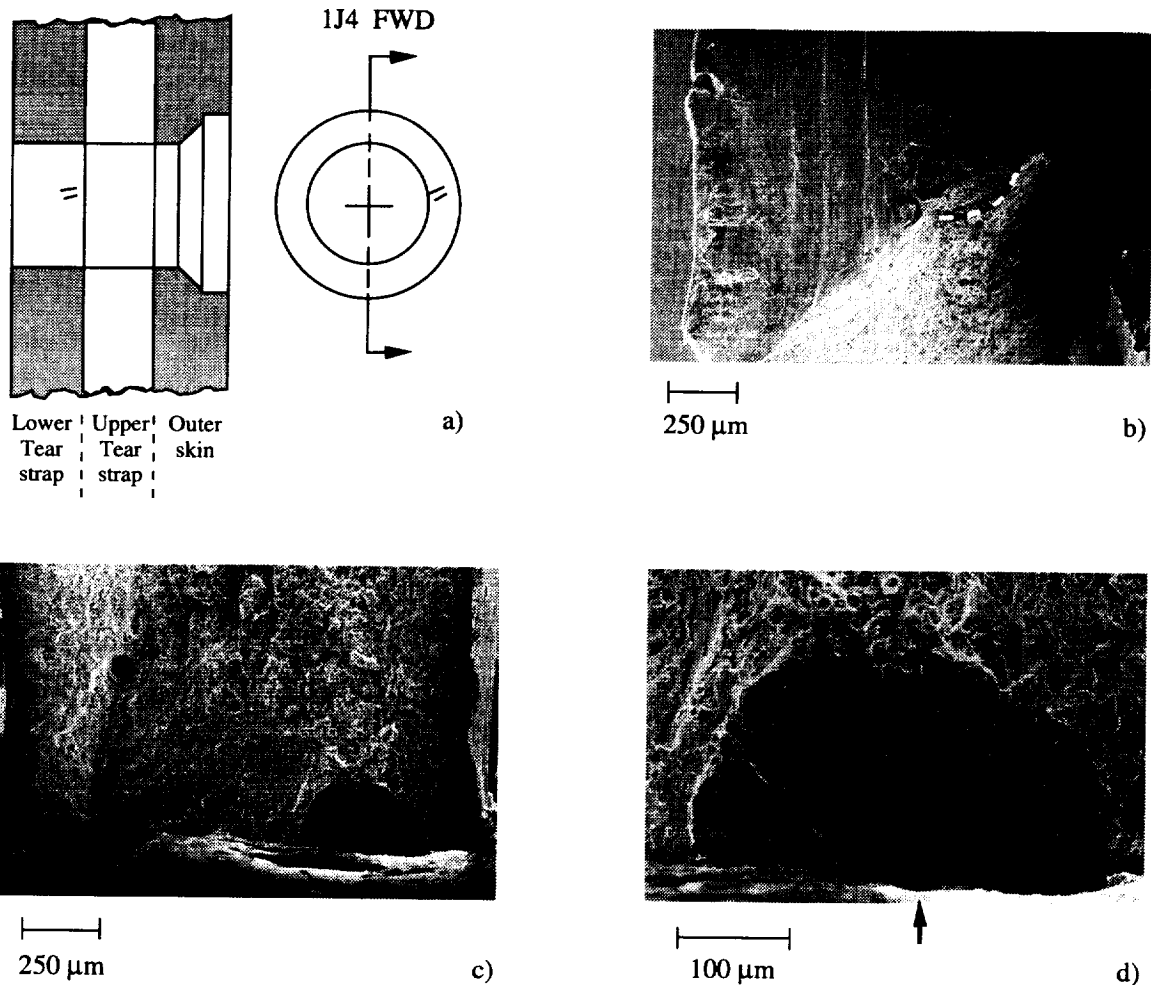
Figure 6.20 a) The schematic shows the rivet hole 1J4 configuration and the location of the lower tear strap fatigue cracks oriented in the forward direction and about the 3 o'clock position. b) The SEM micrograph shows the inside surface of the rivet hole and the fracture surface. The dashed line marks the position of the single surface fatigue crack on the fracture surface. Located above the fatigue fracture surface and on the rivet hole inside diameter are three incipient surface fatigue cracks. c) The SEM micrograph shows the semicircular fatigue fracture surface of the rivet hole surface crack. d) The SEM micrograph shows the semicircular fatigue fracture surface of the rivet hole surface crack at higher magnification. An arrow marks the likely site of fatigue crack initiation, and the dashed line marks the fatigue crack front.

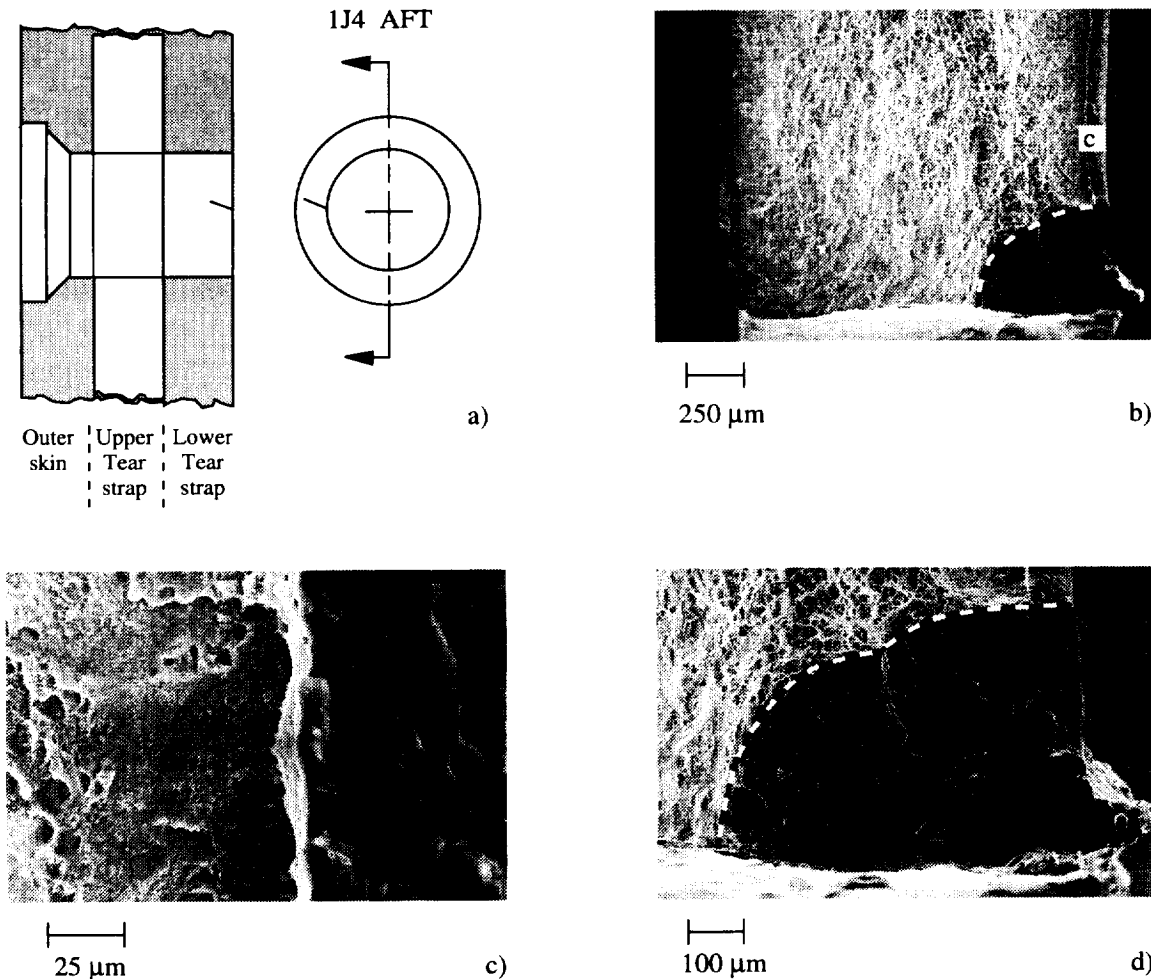
Figure 6.21 a) The schematic shows the rivet hole 1J4 configuration and the location of the lower tear strap fatigue crack oriented in the aft direction and about the 9 o'clock position. b) The SEM micrograph shows fatigue fracture surface of the rivet hole corner crack. Note the corner burr near the likely point of crack initiation (arrow). c) The SEM micrograph shows the clad/alloy interface at region "c" shown in Figure 6.21.c. d) The SEM micrograph shows the fatigue fracture surface of the rivet hole corner crack at high magnification. A dashed line marks the fatigue crack front.

Multiple site fatigue cracking in the lap splice inner skin and tear strap regions were primarily caused by damage at the rivet hole corner and along the rivet hole surface. Examples of corner cracks resulting from high K_T regions are shown in Figures 6.21 and 6.22, where cracks initiated at a corner burr, and Figure 7.34 is an example of a crack initiation from a corner imperfection. Examples of rivet hole fatigue cracking initiation by possible fretting between the rivet shank and the surface of the hole are shown in Figures 6.14-6.17, 6.20, 8.17. In each example, the surface of the hole exhibits a rough surface with microcracks (refer to Figures 6.14.b) in the region of fatigue crack initiation; this is an indication of possible fretting damage. Within hole fatigue crack initiation was also noted at surface imperfections as shown in Figures 8.14 and 8.32.

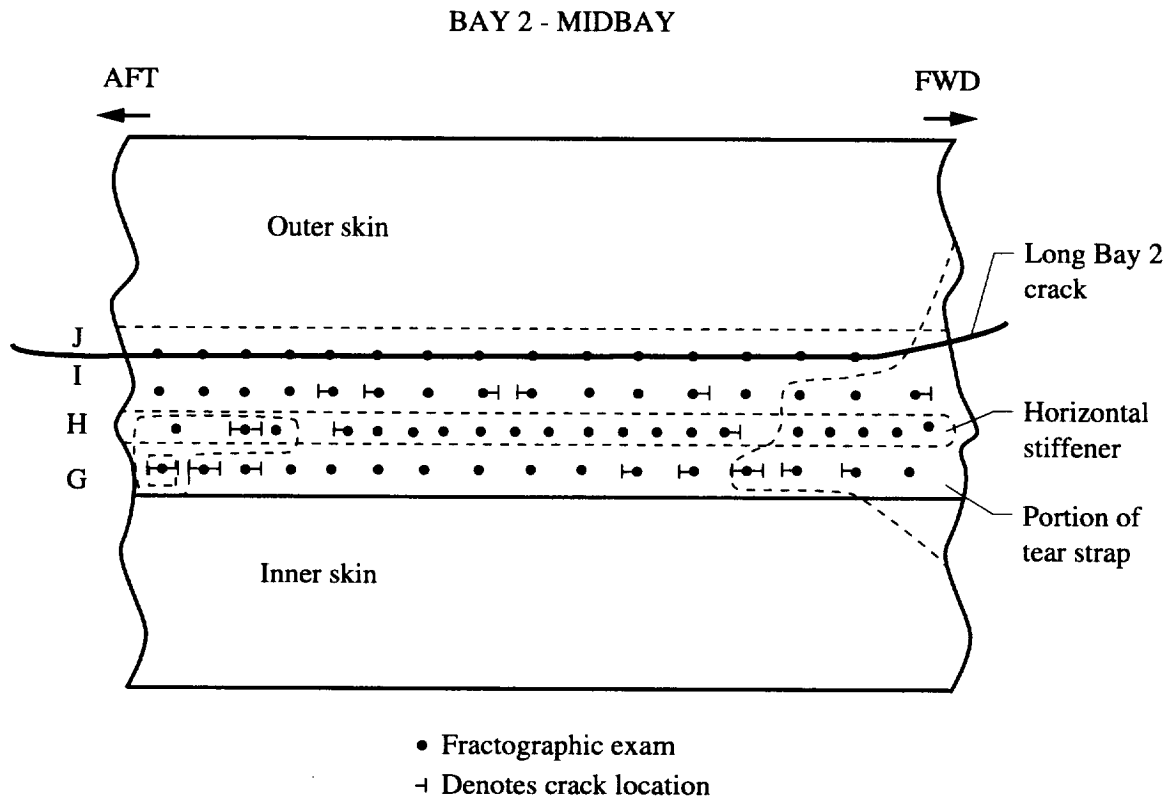
A total of sixty-seven rivet hole locations in bay 2 (identified by the filled hole symbols in Figure 7.1) were destructively examined. All fifteen upper rivet row locations exhibited fatigue cracking (a total of 30 fatigue cracks) prior to crack link-up. A single crack, 47.88 cm (18.85 in.) long, spanning the entire length of the bay 2 lap splice formed when fatigue crack link-up occurred at each upper rivet hole. Twenty-one fatigue cracks were found in the remaining rivet rows contained in bay 2: six cracks in row I, four cracks in row H, and eleven cracks in row G. Figures 7.2 and 7.3 show the location of all fatigue cracks found in the first layer (outer skin) and the second layer (inner skin), respectively. No fatigue cracks were found in the horizontal stiffener or tear strap. Rivet rows J and I contained outer skin cracks and rows H and G contained inner skin cracks. The through-thickness rivet hole schematics shown in Figures 7.4, 7.5 and 7.6 summarize crack location, crack length, crack type, and initiation site for rivet rows I, H, and G, respectively. Because all fatigue cracks are linked in row J and fracture surface detail was destroyed by surface abrasion, a through-thickness schematic detailing fatigue crack information is not shown for the upper row. The following is a detailed description of the fatigue damage in the bay 2 tear strap region. Figures 7.8 through 7.22 are detailed photographs showing the top portion of the long upper row crack (row J) shown in Figure 7.7 and corresponding crack growth data obtained from visual surface measurements performed during pressure testing. Figures 7.23 through 7.43 detail the location and fracture surface morphology of all fatigue cracks found in the remainder of bay 2 (rivet rows G, H, and I).

Figure 7.1 The schematic shows the location of all fatigue cracks found in the bay 2 lap splice joint by destructive examination. The long bay 2 crack is visible in row J. All bay 2 rivet holes were destructively examined.

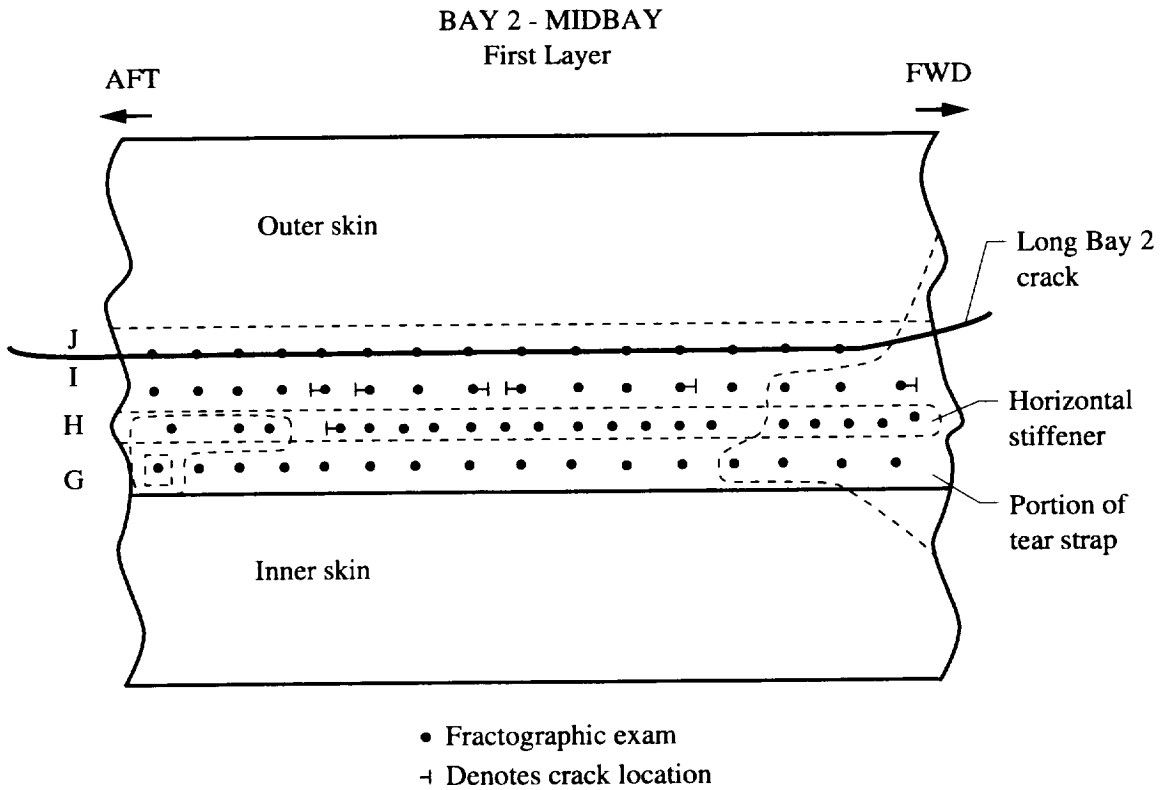
Figure 7.2 The schematic shows the location of fatigue cracks found in the first layer (outer skin) of the bay 2 lap splice joint by destructive examination. The long bay 2 crack is visible in row J.

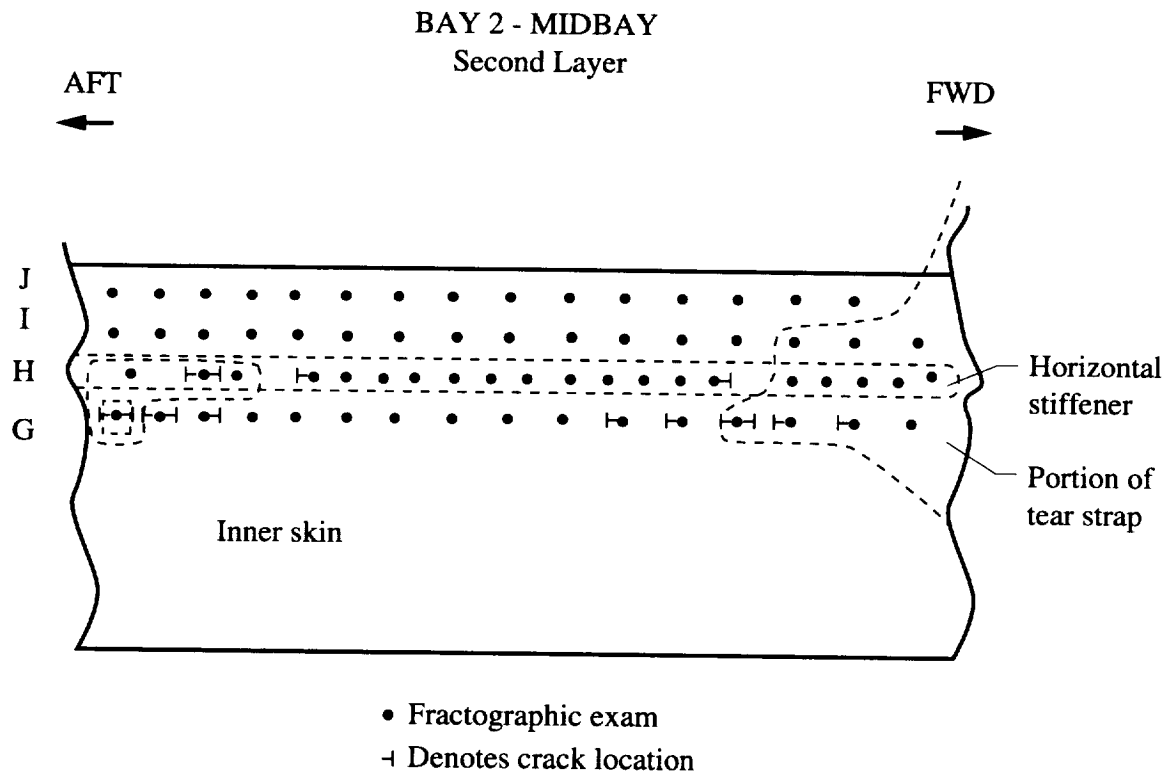
Figure 7.3 The schematic shows the location of fatigue cracks found in the second layer (inner skin) of the bay 2 lap splice joint by destructive examination.

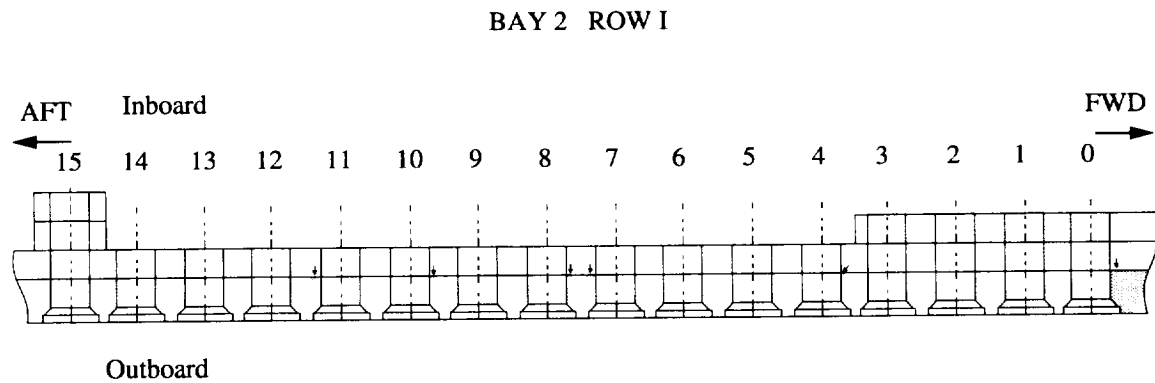
Hole #	Location	Length mm(in)	Type	Initiation-site
0 (FWD)	Outer skin	2.33 (.092)	Through	Inner/outer skin interface
4 (FWD)	Outer skin	0.102 (.004)	Fretting	Inboard corner of shank
7 (Aft)	Outer skin	0.112 (.004)	Fretting	IS/OS
8 (FWD)	Outer skin	0.073 (.003)	Fretting	IS/OS
10 (FWD)	Outer skin	0.140 (.006)	Fretting	IS/OS
11 (Aft)	Outer skin	0.058 (.002)	Fretting	IS/OS

Figure 7.4 The through thickness schematic shows the location and initiation site (small arrows) of fatigue cracks found in rivet row I from bay 2. The table summarizes crack location, crack length, crack type, and initiation site for each fatigue crack shown.

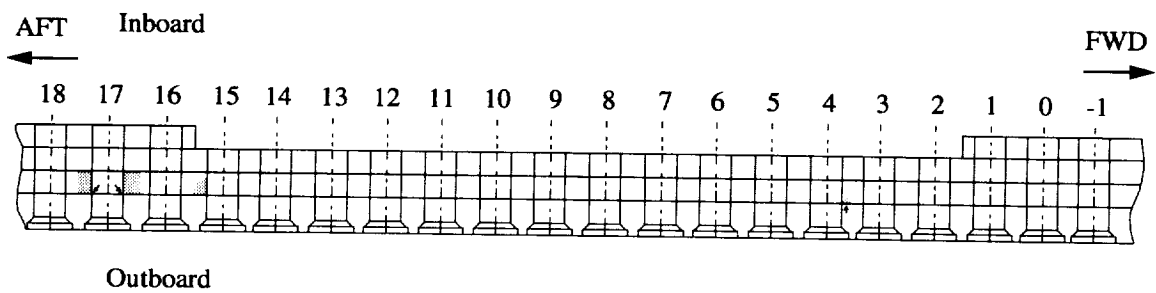
BAY 2 ROW H

Hole #	Location	Length mm(in)	Type	Initiation site
4 (FWD)	Inner skin	0.110 (.004)	Surface	IS / OS Interface
15 (Aft)	Inner skin	ND	Corner	Not determined
17 (FWD)	Inner skin	>2.43 (.096)	Through	Outboard corner
17 (Aft)	Inner skin	>1.63 (.064)	Through	Outboard corner

Figure 7.5 The through thickness schematic shows the location and initiation site (small arrows) of fatigue cracks found in rivet row H from bay 2. The table summarizes crack location, crack length, crack type, and initiation site for each fatigue crack shown.
